## ST JUDE'S CHURCH KENSINGTON

## **06** // Scope of Work

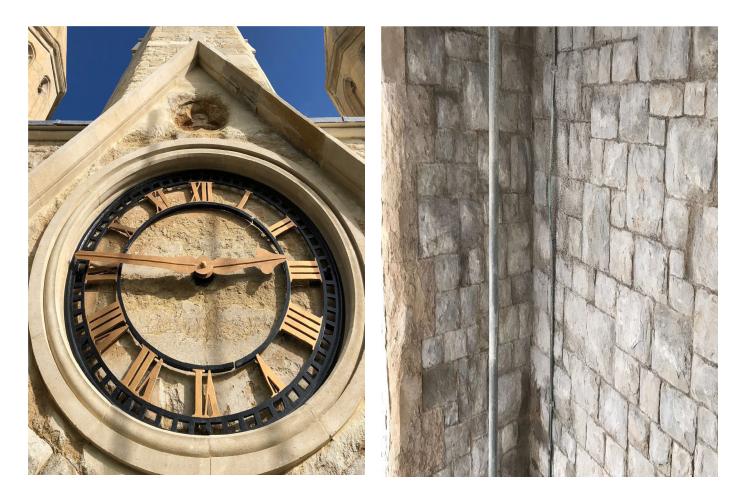
The Bath Stone and Kentish Ragstone were heavily soiled with sulphurous deposits. The heavy clinker was removed carefully by masons hand tools. This was followed by two passes of steam cleaning and whilst the soiling was softened by steam, the jos wet vortex cleaning system was used to gently remove the more stubborn deposits. All cleaning work was carried out by DBR's highly skilled stone cleaners with preparation work undertaken by DBR's skilled stonemasons.

Replacement of eroded bath stone dressings including the spire lucarnes, ashlar stonework, string courses, clock surrounds, gablets and buttresses. The project required a great deal of the stonework installation to be worked to full size templates on site. Lead dressings have also been introduced to the string courses.

The project also included the replacement of glass louvres and quatrafoil windows, stabilisation of the weather vane and spire tension rods, and the installation of structural strengthening to the spire internally by lime grouting and cramping to resist displacement that has occurred.
